EXPLODING CELL PHONE

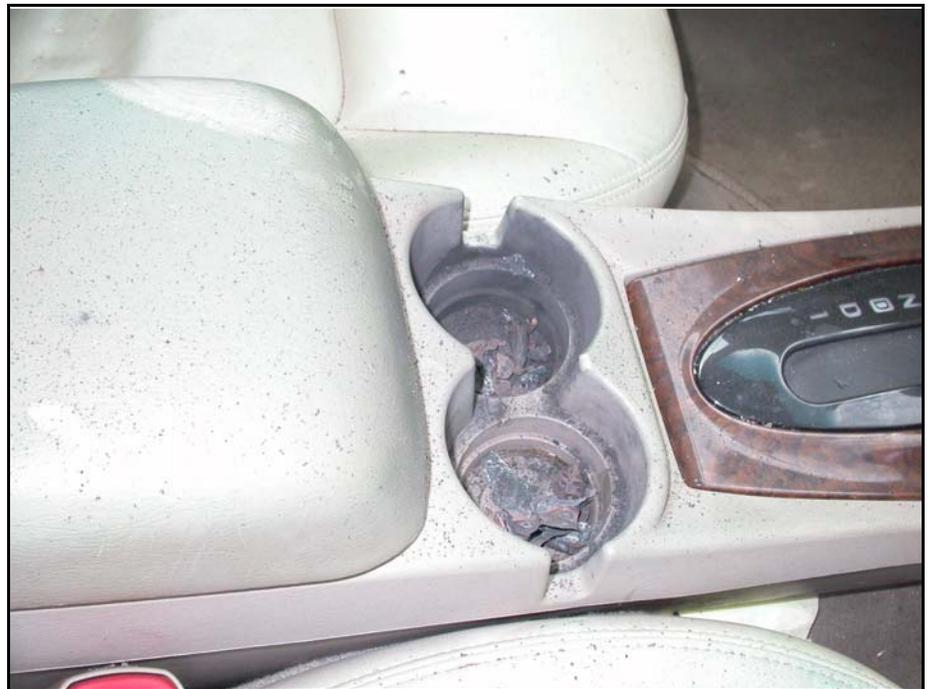
Figure 1

The burn patterns in the passenger compartment were peculiar. A localized fire had burned near the base of the passenger's side front seat, in a spot where no powered devices or electrical wiring had been present. Otherwise, the cup holders on the console between the front seats (where the cell phone had reportedly been placed) were full of metal fragments (see Figure 1). The cup holder on

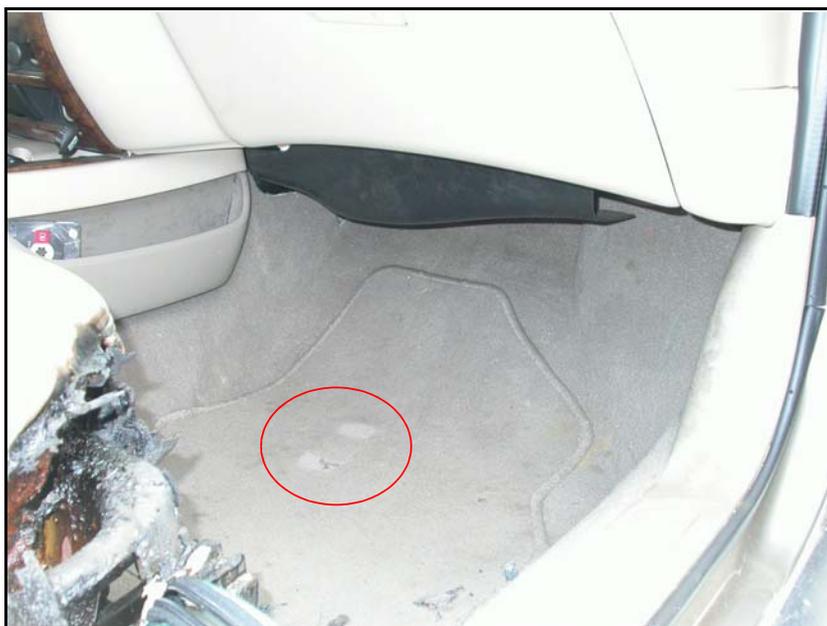
Figure 2

the driver's side was more heavily soot covered than that on the passenger's side. The cell phone, missing its back cover and its battery, was found on the carpet beneath the dashboard, with a "shadow" of the back of the phone (minus its back cover) left behind on the carpet (see Figure 2). Thin metal fragments, accompanied by black dust, were found all around the front seat (see Figure 3). In one case, a scorch mark similar in shape to the fragment was found directly under it (see Figure 4). Figure 5 shows the cell phone, its back cover (which was later found near the console) and the cell phone battery charger. The battery was nowhere to be found.

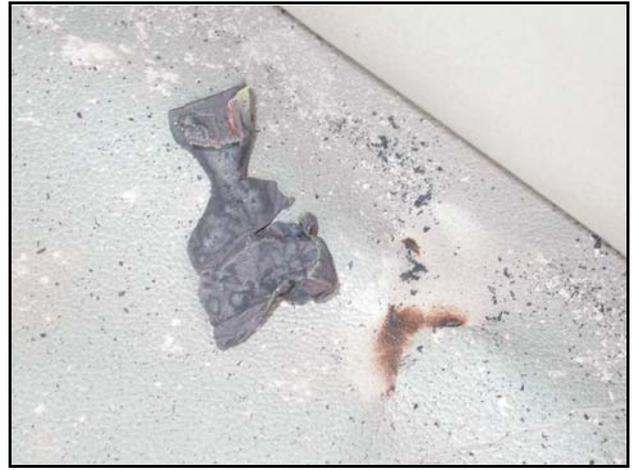
Figure 4

It did not take long to arrive at the conclusion that the cell phone battery had exploded into numerous hot metallic fragments, one of which was sizeable enough to ignite the carpeting on the floor of the
