# BLACK BOX DATA AVAILABILITY

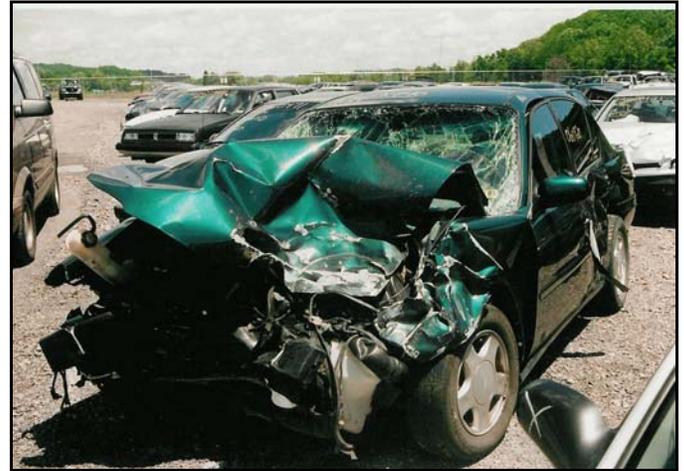
Figure 6 shows a 2000 Chevrolet Malibu that was involved in a head-on collision with a Nissan Maxima that crossed the center line on an interstate highway. One of the issues involved was whether the Malibu driver made reasonable efforts to avoid the collision. Figure 7 is a summary of data downloaded from the Malibu. The data shows that the Malibu had been traveling at a speed of approximately 71 MPH (the speed limit was 70). The driver’s foot was off the gas and the throttle was almost fully closed for the entire 5 seconds leading up to the collision. At a time between 2 and 3 seconds before the collision, the driver braked, reducing his speed to 47 MPH one second before impact. Another part of the data output shows that his car lost about 35 MPH in the collision. From this data and from the impact location (on the shoulder of the highway), it was clear that the Malibu driver had made an effort to avoid the collision. Figure 7 also shows that the driver was not wearing his seat belt at the time of the collision.
